Engineering Geological Assessment of Selected Landslide Dams Formed from the 1929 Murchison and 1968 Inangahua Earthquakes

A thesis
submitted in partial fulfilment
of the requirements for the degree
of
Master of Science in Engineering Geology
at the
University of Canterbury
by
Timothy Richard Nash

UNIVERSITY OF CANTERBURY

2003

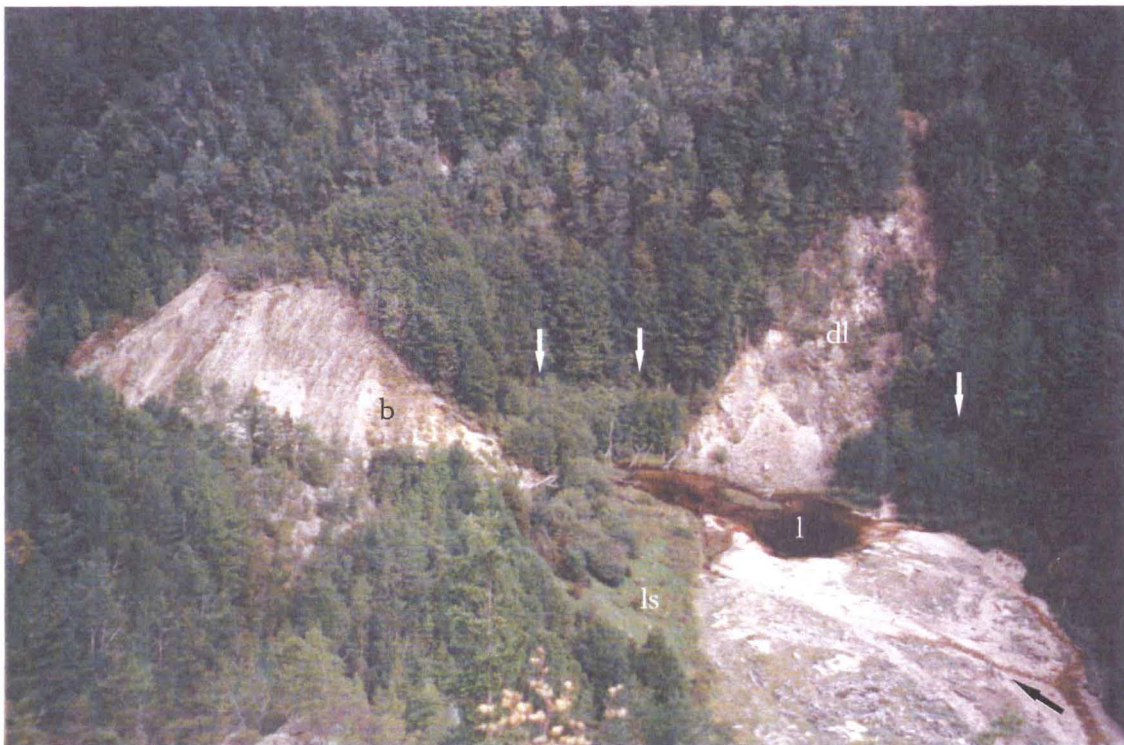
Fig 5.14. Photograph looking southwest at the Rain Peak dam and lake complex post failure (location 8, Map 3) illustrating the breached dam section (b), landslide (triggered by rapid lake drawdown) (dl), the present lake (l) and lake sediments from the original lake prior to breaching. The arrows indicate the original lake level prior to breaching. Dam forming landslide movement direction from top left of the photograph. Stream flow is from right to left (black arrow) (Photo taken April, 2002).

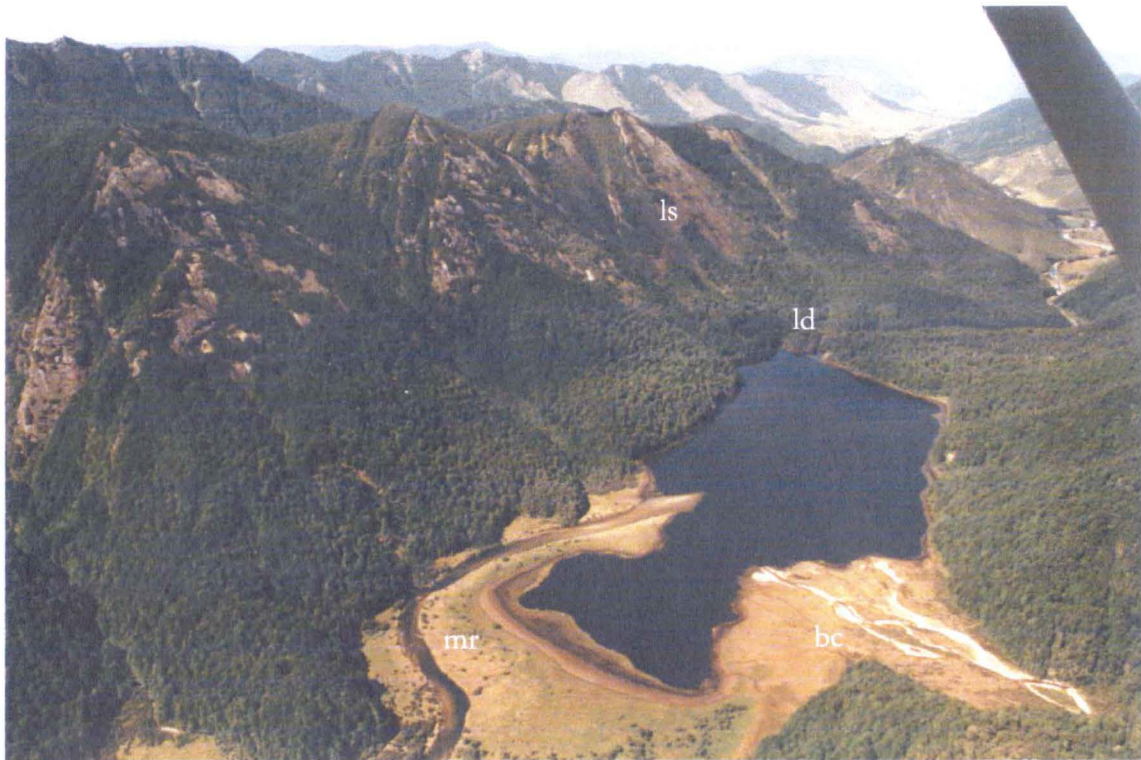
Fig. 5.15. Oblique areal photograph of Lake Matiri landslide dam (ld) looking southeast. Matiri River (mr) enters the top left of the lake, while Bay Creek (bc) tributary enters the top right, both forming large deltas that are slowly filling Lake Matiri. Landsliding (ls) from the eastern valley wall has formed the dam. Note the ridge protruding into the valley at right angles to flow enhancing the stability of the dam. .

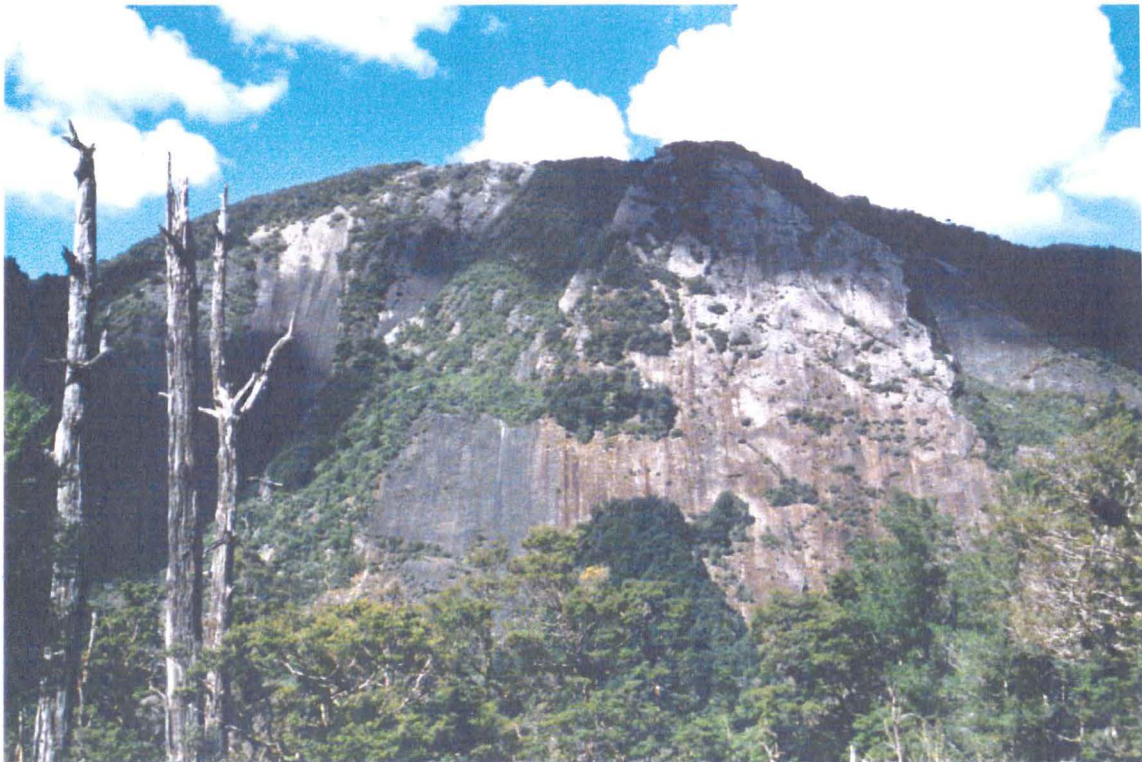
Fig. 5.16. Photo looking east at the steeply dipping ($> 60^\circ$) calcareous sandstone landslide source area. The slickensided planar nature of the bedding plane is evident in the photo as vertical lineations running the length of the slope. This indicates movement has occurred on the bedding surface in the past. Photo taken in February 2003 (Location 1, Map 4).
